# JOB SUMMARY

From	Southern Outdoor Restoration 3217 Northside Drive Raleigh, NC 27615 (919) 366-7474
Job No.	19827739	Job For	American Asset Corporation
Date	10/18/2020		Brier Creek Commons, LLC
Type	Cleaning		Brier Creek Parkway
PO No.			Raleigh, NC 27617

This quote is for the labor and materials to chemically remove the calcium and lime from the wall of the Azitra patio. We will also remove any organic growth after the calcium and lime has been removed. We will access water to complete this work from the exterior commercial spigots throughout this project.

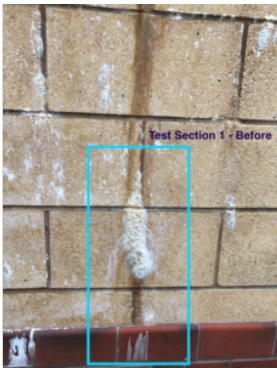
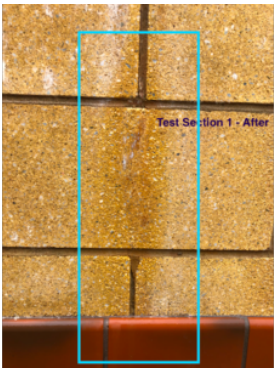
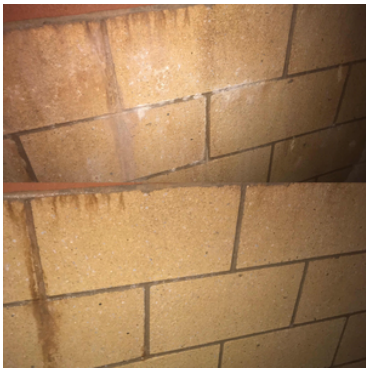
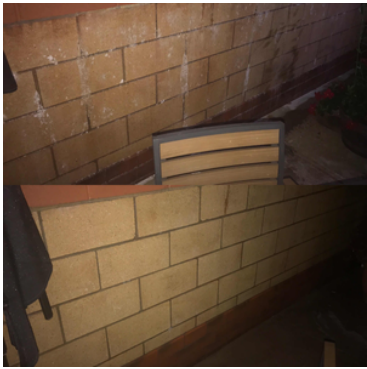
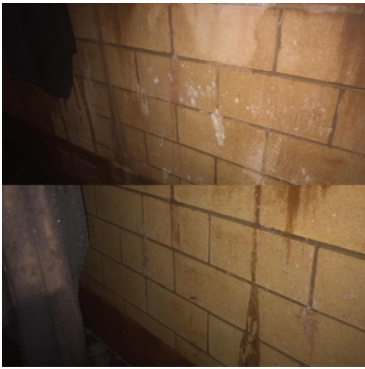
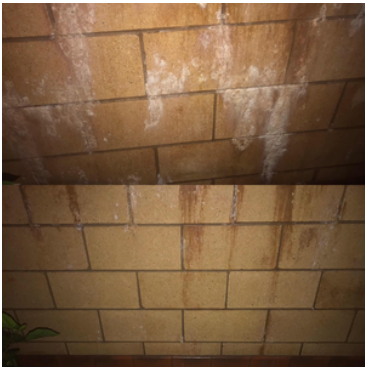
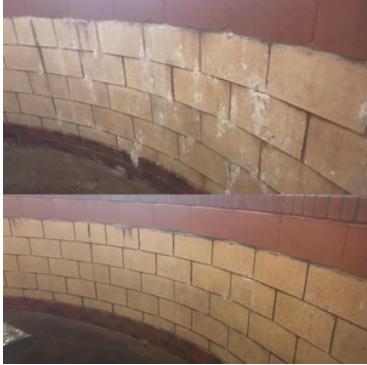
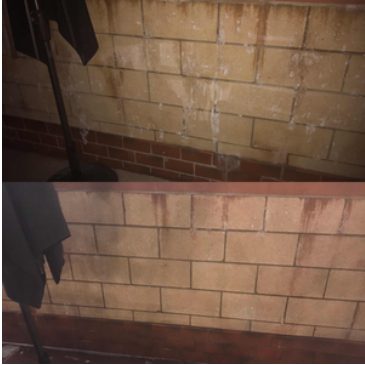
## Files and Photos

- Remove heavy calcium deposits from back wall of Azitra patio with calcite presoak and NMD80. Agitate with wire brush and reapply chemicals as needed.
- Treat wall and 40 tip to remove organic growth after calcium is removed.

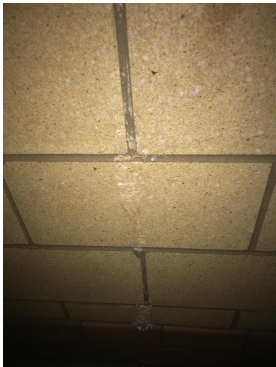
Description:  
Brick chipped when 40 tipped

Was able to complete a section of wall.. Again applying several applications of remover and MD80. Used a scrapper to scrape the really thick areas along with purchased wired brushes. Remove about 85 percent of calcium.. Some places of brick chipped in the process of 40 tipping.(see deficiency).Will return tonight to complete another section. Everything cleaned up pretty well..

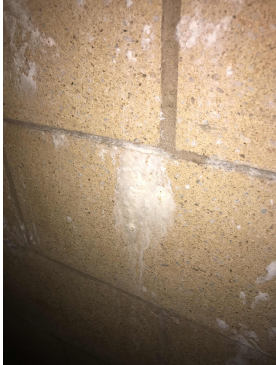
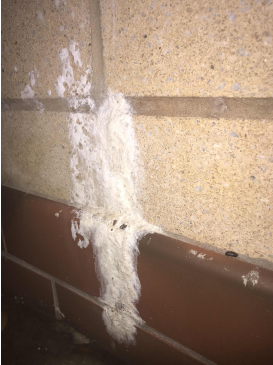
Description:  
Thick calcium

This section of wall has really thick calcium.. Used scrapper and brush to at least get some of it knocked down smooth.. We did remove some calcium but still no real luck removing all.. sand blasting would be ideal for this job..
